## Comfort Station at 230 South Street

### ADA Transition Plan

October 2021

**Town of Barnstable  
Comfort Station at 230 South Street**

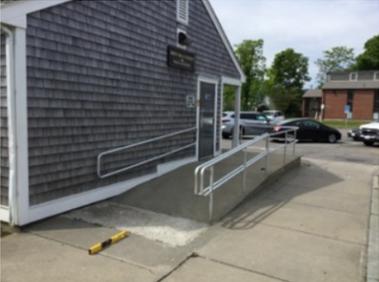
ID	Location	Floor	Room	Element	Type	Photo	Issues	Current Measure	Recommendations	Quantity	Price	Cost Estimation
<b>Approach and Entrance</b>												
<b>Exterior Ramp</b>												
1	Towards Comfort Station	Ext.		Exterior Ramp

Edge protection < 4" high	-	Provide edge protection that prevents the passage of a 4" diameter sphere, where any portion of the sphere is within 4" of the finished floor or ground surface.	1	1260	\$1260
2	Towards Comfort Station	Ext.		Exterior Ramp	N/A

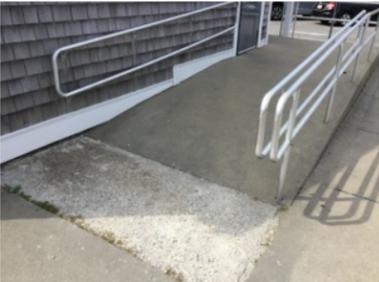
Not maintained in operable working condition	-	Ensure the ramp is maintained in operable working condition.  (Cost for a 4 ft. by 2 ft. concrete route.)	1	200	\$200
<b>Access to Goods and Services</b>												
<b>Interior Access Route</b>												
3	Men's Toilet Room	1		Interior Access Route	N/A

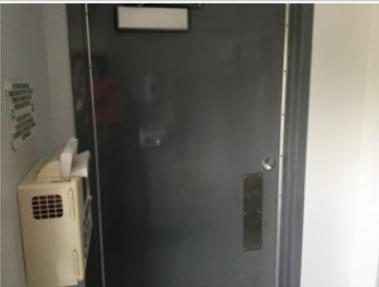
Obstructed by protruding objects	5.5"	Relocate medicine kit so it does not protrude into the circulation path.	1	256	\$256

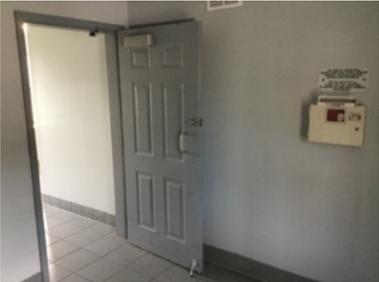
4	Women's Toilet Room	1		Interior Access Route	N/A

Obstructed by protruding objects	5.5"	Relocate medicine kit so it does not protrude into the circulation path.	1	256	\$256

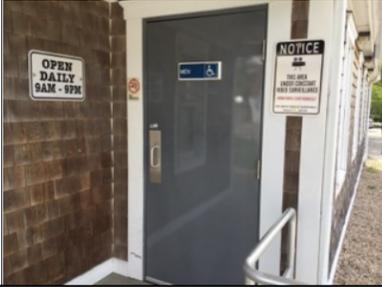
ID	Location	Floor	Room	Element	Type	Photo	Issues	Current Measure	Recommendations	Quantity	Price	Cost Estimation
<b>Doors, Doorways, &amp; Gates</b>												
5	Men's Toilet Room	Ext.		Doors, Doorways, & Gates	Toilet Room

Maneuvering clearance(s) not provided	12"	Provide an automatic door opener.	1	3060	\$3060
<b>Signage</b>												
6	Men's Toilet Room	Ext.		Signage	Designation

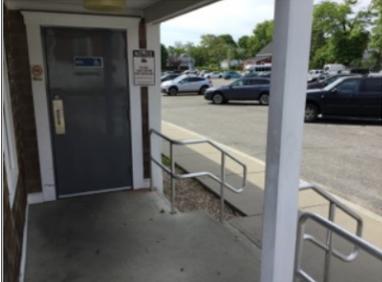
Raised characters not provided on sign Braille not provided on sign Sign not located on the latch side of the door	- - -	Provide text with raised characters duplicated in braille on sign. Locate sign alongside the door on the latch side.	1	232	\$232
7	Women's Toilet Room	Ext.		Signage	Designation

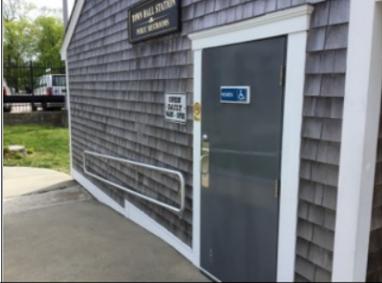
Raised characters not provided on sign Braille not provided on sign Sign not located on the latch side of the door	- - -	Provide text with raised characters duplicated in braille on sign. Locate sign alongside the door on the latch side.	1	232	\$232

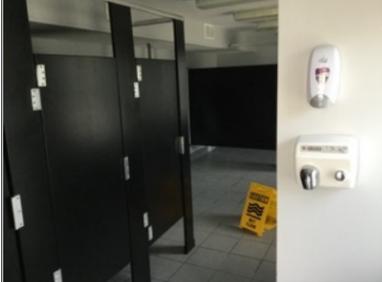
Reach < 15" or > 48"(forward/side approach)	57.5"	Locate hand sanitizer 48" max. above the finished floor.	1	Labor	\$0

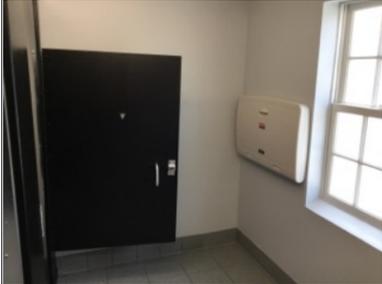
ID	Location	Floor	Room	Element	Type	Photo	Issues	Current Measure	Recommendations	Quantity	Price	Cost Estimation
<b>Toilet &amp; Bathing Rooms</b>												
<b>Overall Access</b>												
10	Men's Toilet Room	1		Overall Access	Toilet Room

Audible and visible alarms not provided	-	When fire system is updated, ensure that a visible and audible fire alarm is installed.	1	-	\$0
11	Women's Toilet Room	1		Overall Access	Bathing Room

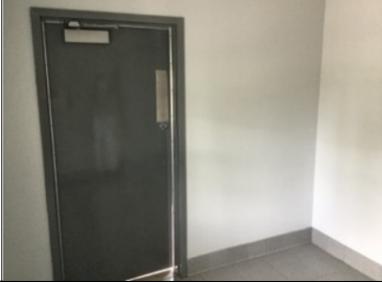
Audible and visible alarms not provided	-	When fire system is updated, ensure that a visible and audible fire alarm is installed.	1	-	\$0
<b>Lavatory</b>												
12	Men's Toilet Room	1		Lavatory	N/A

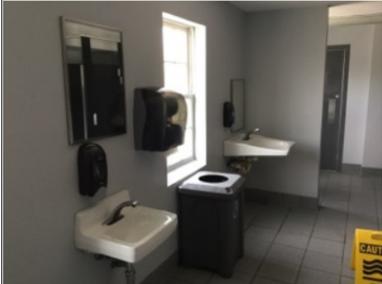
Ensure pipes at the accessible lavatory are fully insulated to prevent contact.	1	Labor	\$0
13	Women's Toilet Room	1		Lavatory	N/A

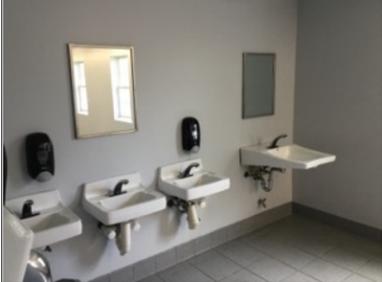
Plumbing underneath is exposed Mirror above lavatory w/reflective surface > 40"	- 47"	Insulate or otherwise configure pipes to prevent contact at the accessible lavatory. Lower mirror so that the bottom surface is at 40" max. above the finished floor.	1	348	\$348

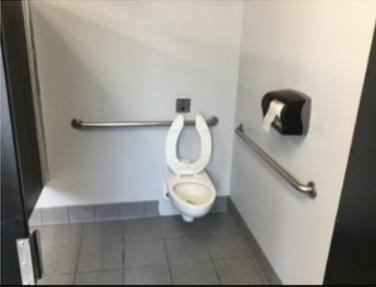
ID	Location	Floor	Room	Element	Type	Photo	Issues	Current Measure	Recommendations	Quantity	Price	Cost Estimation
<b>Toilet Compartment</b>												
14	Men's Toilet Room	1		Toilet Compartment	Accessible Compartment

Door has malfunctioning self-closing hinge Non-compliant toilet paper dispenser	- -	Repair hinge. Relocate toilet paper so that it is 24" min. high, located under the grab bar, and between 7" and 9" from the front of the toilet.	1	256	\$256
15	Women's Toilet Room	1		Toilet Compartment	Accessible Compartment

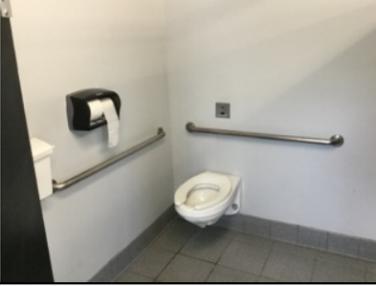
Door has malfunctioning self-closing hinge Non-compliant toilet paper dispenser	- -	Repair hinge. Relocate toilet paper so that it is 24" min. high, located under the grab bar, and between 7" and 9" from the front of the toilet.	1	256	\$256
16	Women's Toilet Room	1		Toilet Compartment	Ambulatory Compartment

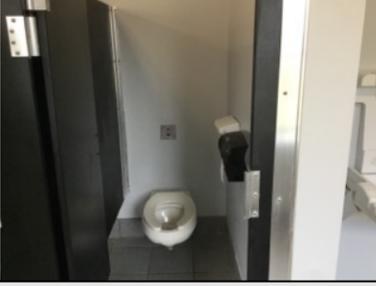
Side grab bar < 42" long	-	Provide two side wall grab bars that are 42" long min. Ensure the ambulatory accessible compartment is between 35"- 37" wide.	2	898	\$1796

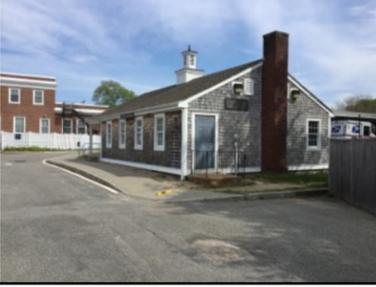
<b>Best Practice</b>												
<b>Bench</b>												
17	Sidewalk to Comfort Station	Ext		Bench	N/A

Recommend providing at least one bench at this location.	1	-	\$0

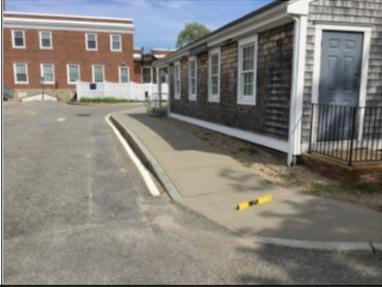
ID	Location	Floor	Room	Element	Type	Photo	Issues	Current Measure	Recommendations	Quantity	Price	Cost Estimation
<b>Detectable Warning</b>												
18	Sidewalk to Comfort Station	Ext		Detectable Warning	N/A

Recommend providing a detectable warning at the curb ramp.	1	-	\$0
<b>Step</b>												
19	Stair to Sidewalk	Ext.		Step	N/A

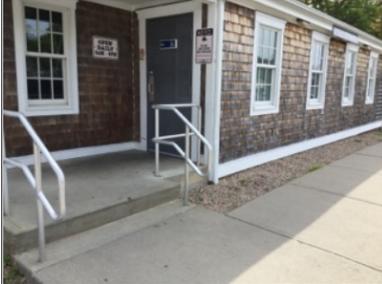
Recommend adding contrasting strips at the edge of the step.	1	-	\$0
<b>Trash Receptacle</b>												
20	Women's Toilet Room	1		Trash Receptacle	N/A

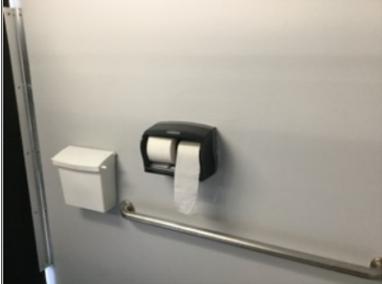
Recommend locating the trash receptacle closer to the toilet. Ensure is located below the side grab bar.	1	-	\$0
